# MATRIXCOTE® SYSTEM

## Background

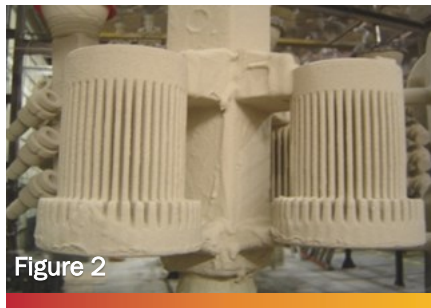
2. Reduce or eliminate positive metal defects. With the existing system, there were certain part configurations that required nearly 100% rework due to positive metal. Figure 2 shows one of the most challenging parts chosen for this measurement.

Photos from left to right show parts experiencing cracking, positive metal and permeability defects.

Scrap and rework associated with positive metal on parts shown in Figure 2 were decreased significantly after a simple wetting agent adjustment in the intermediate slurry made with the Matrixcote system. Similarly, gas defects previously seen on the parts shown in Figure 3 were eliminated. The foundry moved the Matrixcote system onto one robot system. After consuming all the existing material on the second robot, it also was converted to the Matrixcote system.

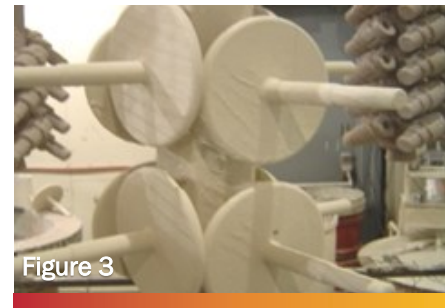
3. Increase permeability to reduce or eliminate defects. Figure 3 shows one of the parts chosen for this measurement.
4. Accomplish these goals without adding backup coats to the process. The existing system allowed the foundry to decrease the number of backup dips that they needed previously, by one coat.
